## Potential for Native Aquatic Plant Growth after Control of Eurasian Watermilfoil in Crooked Lake, MN (# 02-0084-00)

June – August 2011

James A. Johnson – Aquatic Ecologist, Freshwater Scientific Services, LLC

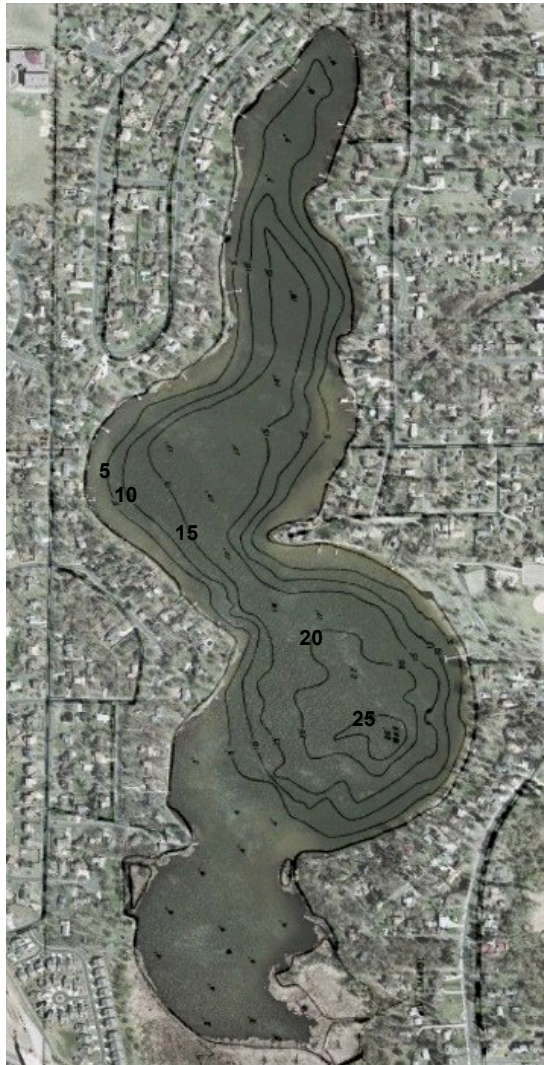
Figure 2. Map of Crooked Lake showing depth contours (MDNR bathymetric map superimposed on aerial image)

Crooked Lake (#02-0084-00) is a small and relatively shallow lake (Table 1) that straddles the border between Coon Rapids, MN and Andover, MN (Figs. 1 and 2). The lake has a public boat access at the far northern end of the lake, and is predominantly used for fishing, waterskiing, and swimming.

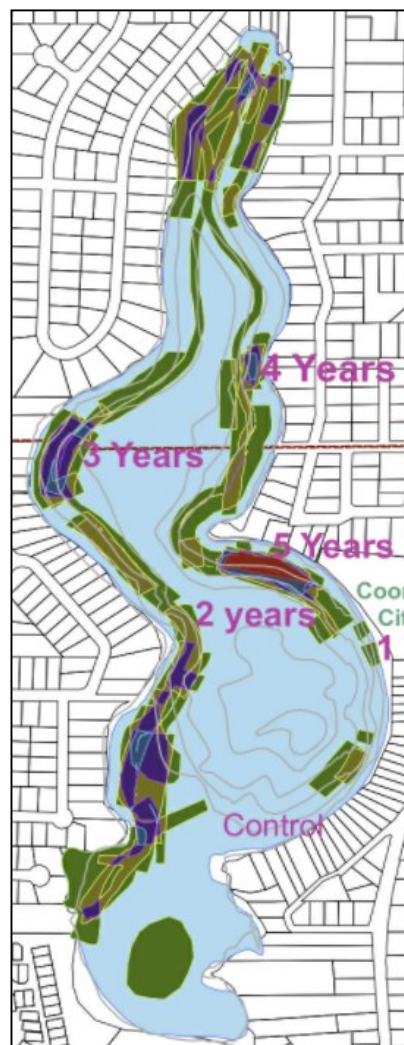
**Figure 3.** Map of Crooked Lake showing areas that received herbicide spot treatments between 2005 and 2010 (provided by CCWD).

Since 2002, milfoil in Crooked Lake has been managed using localized “spot” herbicide treatments that limited herbicide applications (2,4-D or triclopyr) to areas that supported milfoil growth (Fig. 3). In most years, this approach provided short-term control of milfoil growth in the treated areas, and did not appear to dramatically reduce native plants. However, these treatments did not appear to provide long-term control of the milfoil, as it generally reestablished in many of the treated areas in the subsequent years if left untreated. Consequently, many areas have received treatments in multiple years over the past decade.

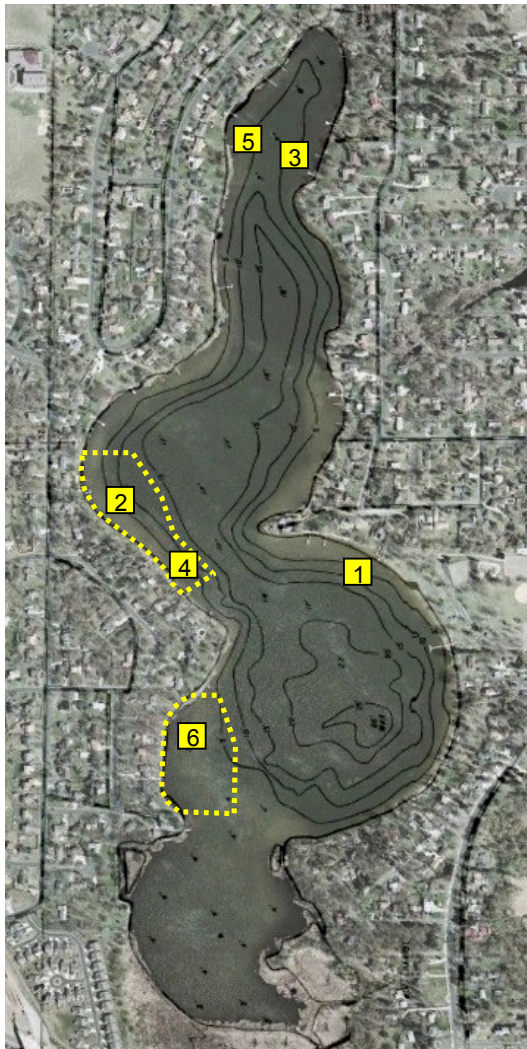
**Figure 4.** Map showing location and identification of the 6 study plots used in the 2011 study, and the areas treated with triclopyr in 2011 (dashed lines). Plots are numbered according to water depth from deepest (plot 1) to shallowest (plot 6). Plot symbols in map do not reflect the actual size of the plots.

In the spring of 2011, we selected 6 nearshore locations for our study plots. All of these selected locations were in areas that had been infested with milfoil in recent years, and that had received some herbicide treatment in the past 5 years. Three of the study plots were located in areas that were treated with triclopyr in 2011, with the remaining 3 plots located in areas that were not treated in 2011 (Fig. 4). These plot locations covered a range of water depths from 2.5 to 6.0 feet and were generally distributed throughout the lake (Figs. 4 and 5). The lake sediment in all six plots was soft, marl, muck, with the southwestern plots appearing to have more marl than the northern and eastern plots.

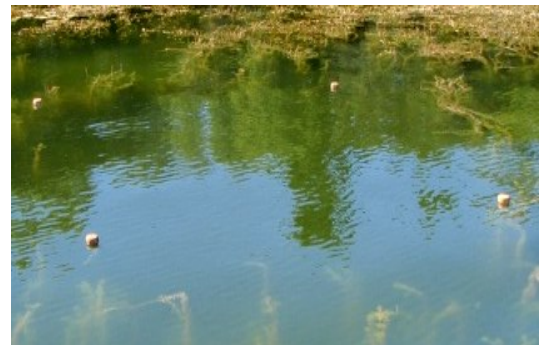
**Figure 6.** Study plot (plot 2) showing delineated area (12 x 12 ft) and installed plot markers.

On June 14, 2011, we installed plot markers to delineate all 6 study plots. These plot markers were constructed of PVC pipe with a small donut-style, fish-net float attached to one end by 2 ft of nylon rope (Fig. 6). For each plot, we placed the markers at the corners of a 12 x 12-ft square by pushing the PVC markers into the sediment until the rope became taut and the float was held in place at the surface of the water. Although the plots were all fairly close to shore, we wanted to make sure that the markers would not damage boats that accidentally ran over them. In addition, we used low-visibility markers to maintain views of the lake from shore and to reduce the likelihood of vandalism. Two plot markers were removed by lake users during the study (one at plot 1 and one at plot 4), but on both occasions we were easily able to replace these markers.

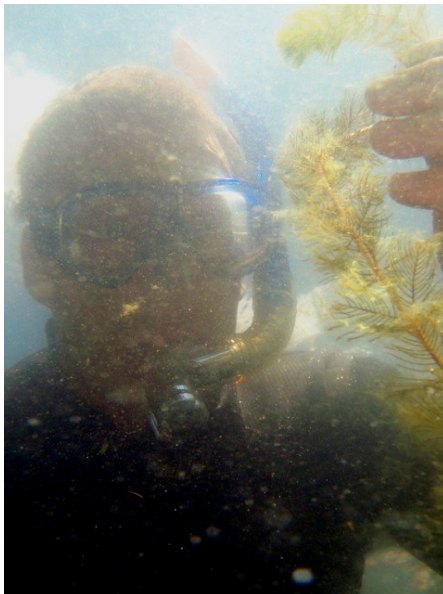
**Figure 7.** James Johnson (Freshwater Scientific Services, LLC) removing Eurasian watermilfoil from study plot while snorkeling.

After the plots were delineated, we inspected each plot while snorkeling, and manually removed all of the milfoil growing within each plot (June 14-15; Figs. 7 and 8). During this manual removal, we were very careful to avoid disturbing native plants (no flippers, maneuvered with hands only). In addition, when removing milfoil plants, we removed the entire plant (shoots and roots) to minimize regrowth. All of the collected milfoil plants were placed into a plastic garbage bag and removed from the lake according to MDNR rules. We conducted additional snorkel inspections of the plots on July 7 and July 28. All milfoil plants found growing in the plots during these subsequent inspections were removed using the same procedure as described above. The repeated removal of milfoil dramatically reduced its the abundance in the study plots relative to the areas immediately outside of the plots (Fig. 8).

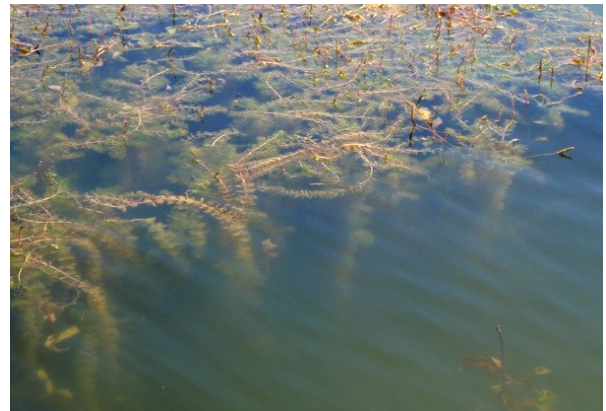
**Figure 8.** Edge of study plot (plot 4) showing dramatically reduced Eurasian watermilfoil inside the plot (foreground) relative to the area immediately outside the plot (background) in August 2011 after periodic removal of milfoil. (Also evident in Figure 6.)

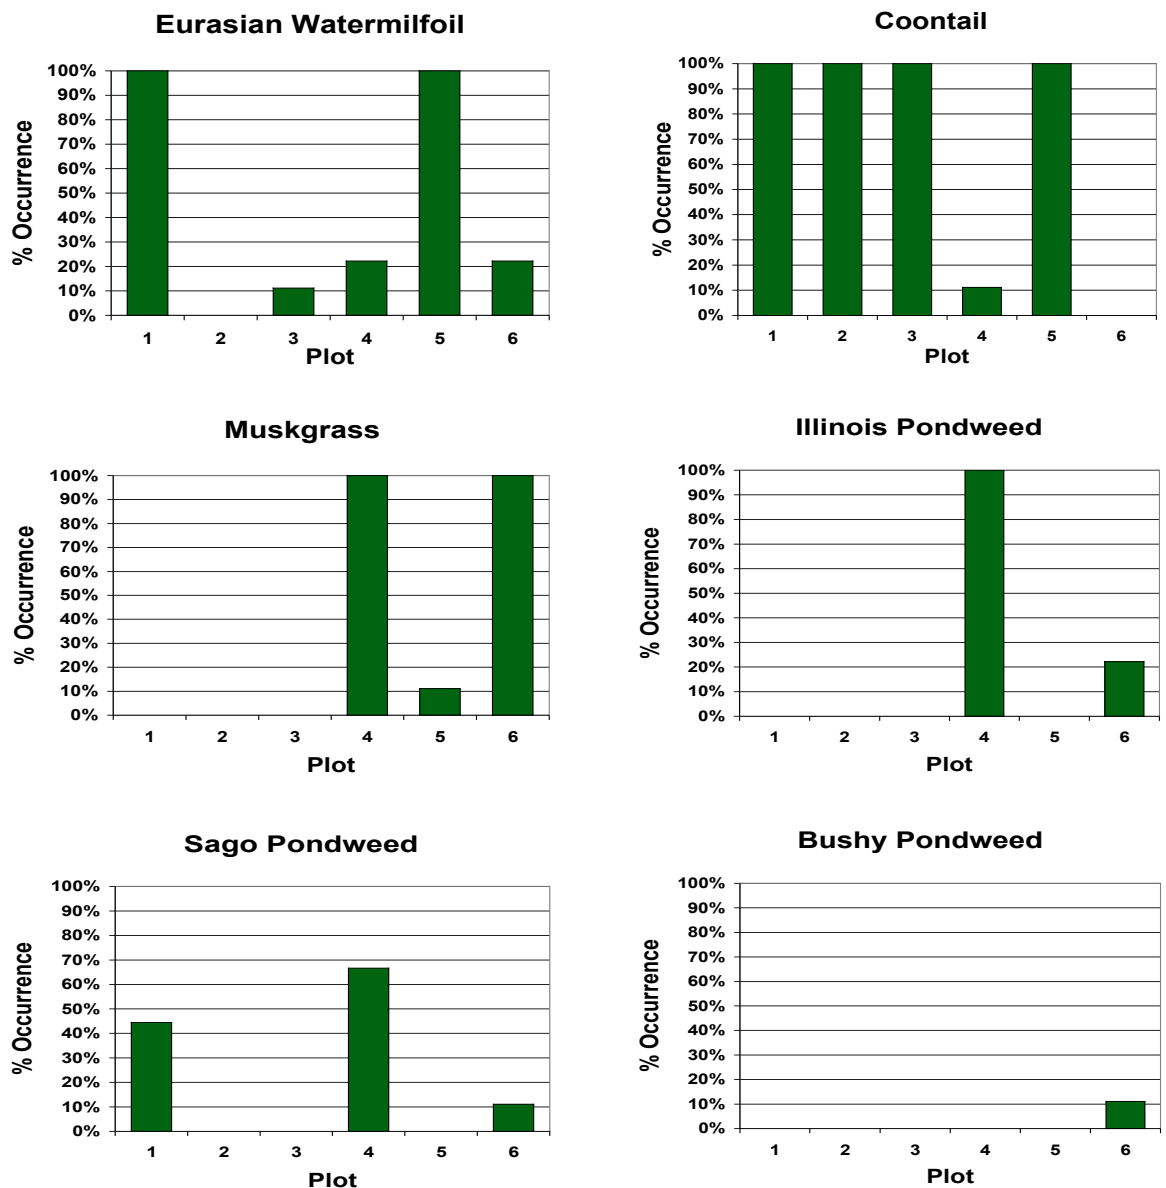
**Figure 10.** Frequency (% occurrence) of plant taxa within each study plot (average of 9 quadrats in each plot).

Frequency indicates how common each type of plant was in our study plots. Comparison of the frequency of each plant taxon across our study plots clearly shows that the frequency of plants differed both between taxa and between plots (Figure 10). Milfoil was found in all of the measured quadrats in both plot 1 and plot 5, but was much less common in the other plots. Interestingly, these plots were not in the areas treated with triclopyr in 2011, suggesting that herbicide treatment suppressed milfoil in the treated areas. Coontail dominated the northern and eastern plots, but was nearly absent from both of the plots along the southwestern shore (plots 4 and 6) where muskgrass dominated. In general, muskgrass seemed to be confined to shallower depths, as coontail dominated the deeper sites. Illinois pondweed and sago pondweed were the most common taxa with vertical growth forms (good habitat structure for larger fish), but were only found at a few locations.

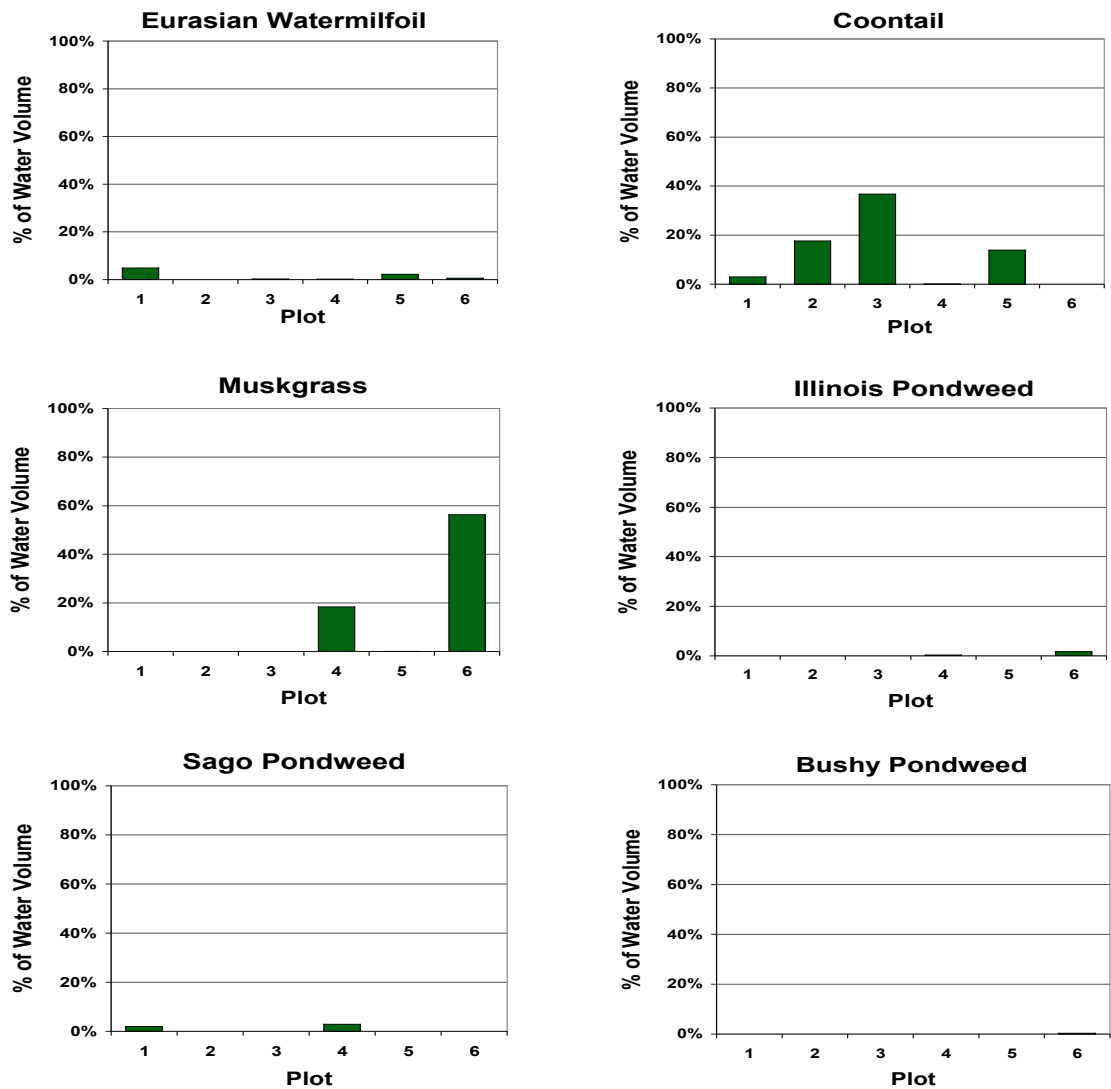
**Figure 13.** Biovolume of aquatic plant taxa within each study plot; average of 9 quadrats in each plot

Biovolume is defined as the percentage of the water volume within a given area that is occupied by plants. In general, greater biovolume means there is more habitat for fish and greater protection of sediments from being stirred up by wind and waves. In our study, calculating biovolume allowed us to combine our measurements of plant height and % cover to give us a better understanding of the overall amount of plant growth in the study plots. In addition, biovolume gives us an idea of which plant taxa would likely be most abundant if milfoil was greatly reduced. Comparison of the biovolume for each plant taxon across our study plots clearly shows that there were large differences both between taxa and between plots (Fig. 13). However, coontail and muskgrass consistently accounted for the majority of the plant biovolume in the study plots. The dense, carpet-like growth of these two plant taxa (1) provides high-quality habitat for small fish and the things they like to eat, (2) protects sediments against disturbance from wind and waves, (3) oxygenates the lake, and (4) absorbs nutrients that are released from the sediment. Furthermore, the dense carpet may slow the reestablishment of milfoil, allowing control measures to maintain low milfoil abundance.
