# **Abundance of Curlyleaf Pondweed Turions in the St. Croix Flowage – Douglas County, WI** (WBIC 27-403-00)

**October 2011**

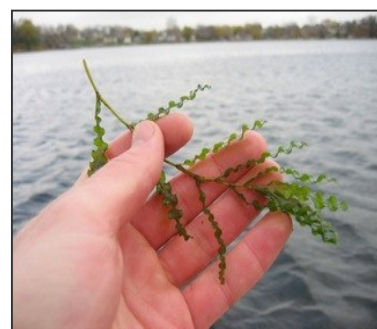
**Figure 1.** Curlyleaf life-cycle in northern lakes (left); curlyleaf plant (below).

Curlyleaf (*Potamogeton crispus*) is an invasive aquatic plant that typically forms dense surface growth and displaces native aquatic plants (Madsen and Crowell 2002). Consequently, it has dramatically reduced the recreational and ecological quality of many lakes in the upper Midwest (Catling and Dobson 1985, Bolduan et al. 1994). Curlyleaf's ability to dominate the plant community in lakes is enhanced by its novel life-cycle (Tobiessen and Snow 1984). Although it is considered a perennial species, it behaves as a winter annual in northern lakes (Netherland et al. 2000, Madsen and Crowell 2002), sprouting from turions (reproductive buds) in the fall, persisting as small shoots under the ice during the winter, growing rapidly in the early spring (Kunii 1982, Tobiessen and Snow 1984), and forming dense surface growth and new turions in May and June (Wehrmeister and Stuckey 1992, Bolduan et al. 1994). Curlyleaf plants typically die off by mid-summer, depositing any newly-produced turions to bottom of the lake. Although this means that the dense matted growth is generally short lived and out of the way by the 4<sup>th</sup> of July, deposited turions in lake sediments lead to new curlyleaf growth in subsequent years. Although curlyleaf also produces seeds, under most conditions its annual life-cycle is almost entirely dependent upon sprouting from turions in lake sediments (Rogers and Breen 1980, Sastroutomo 1981, Bolduan et al. 1994). Consequently, there is great interest in adopting management strategies that can prevent turion production, deplete accumulated turions, and thus decrease nuisance growth.

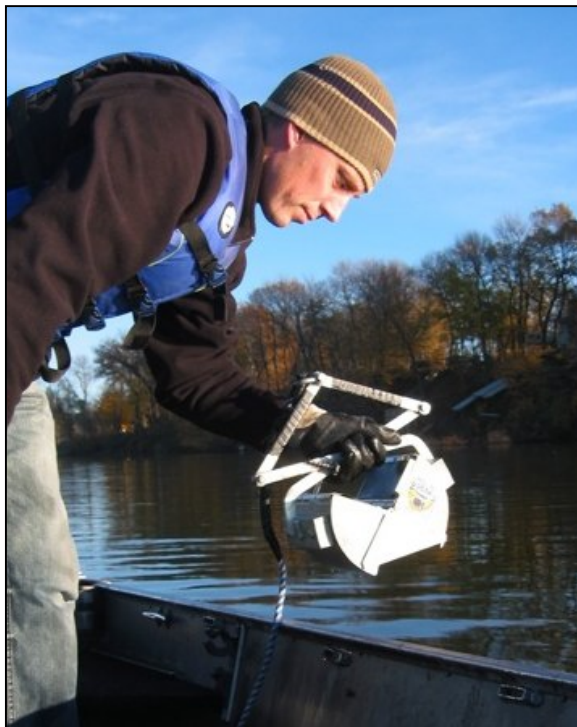
**Figure 5.** J. Johnson (Freshwater Scientific Services, LLC) collecting sediment samples with a petite Ponar grab sampler (left); sprouted curlyleaf pondweed turions (above)

On October 27, 2011 Freshwater Scientific Services, LLC collected sediment samples at all 80 identified sample locations (Fig. 4). At each location, we collected one sediment sample using a petite Ponar dredge (225 cm<sup>2</sup> basal area, sample depth ~10 cm). Upon retrieving each sediment sample, we removed any material from the outside of the closed dredge, emptied the sampler contents into a sifting bucket (1-mm screen), and gently sifted the sample to remove fine sediment. The contents remaining in the bucket after sifting were placed into a labeled plastic bag and stored in a cooler while in the field. In the lab, we manually sorted turions from other debris and recorded total turion counts for each sample. Small turion fragments (those that did not include a portion of a central turion stem) and severely decayed turions (those that did not retain their shape when lightly squeezed) were discarded and were not included in the final turion counts.
