2006 Lawn Runoff Monitoring Report: Weaver Lake

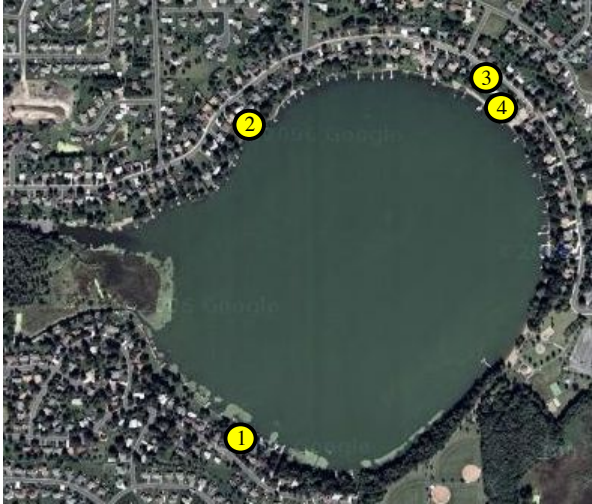
Figure 4. Location of the four monitored locations. Sites 1, 2, and 4 are backyard locations, and site 3 is along the curb on the street side of the chosen property.

The samplers were installed to collect surface runoff from an area 2-meters wide with a minimum of 20 feet of uphill slope. All sites were in areas of open lawn with no tree canopy. Three of the samplers were installed at the bottom of backyard slopes that drained directly to Weaver Lake, while the third sampler was installed immediately adjacent to the curb on the street side of the property to monitor lawn runoff flowing onto the street and into the nearby stormwater catch basin (Figure 4).

- 1 – Very flat, poorly drained backyard slope with wet sandy soils and dense turf. Sampler placed to intercept observed channelized flow to beach area. (< 30:1 slope)
- 2 – Steep, well drained backyard slope with dense turf. (~ 4:1 slope)
- 3 – Relatively flat, well drained, front yard slope with compacted areas and some roof drainage. (~ 12:1 slope)
- 4 – Relatively steep, well drained backyard slope with sandy soils (~8:1). (This site was accidentally destroyed during landscaping.)

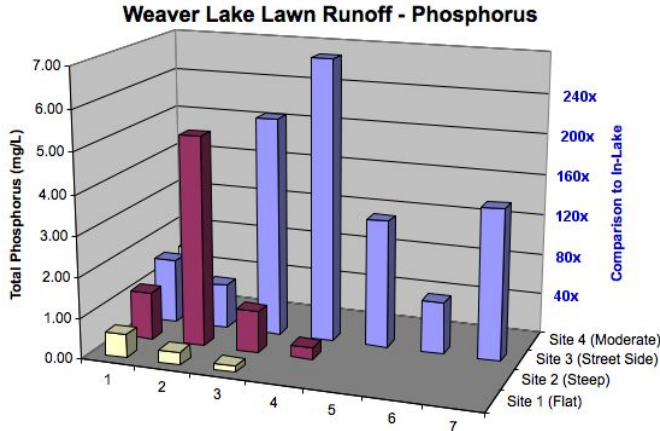
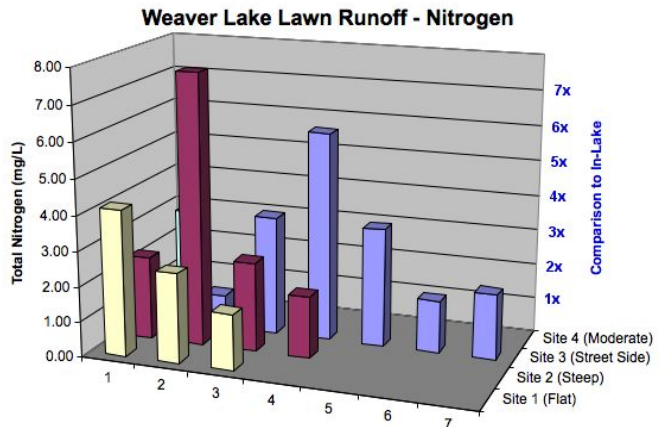
Figures 5 and 6. Graphical summary of lab results for total phosphorus (TP) and total nitrogen (TN) for each of the 7 rain events sampled in 2006. The blue text along the right margin of each graph relates the measured runoff concentrations to the average in-lake concentrations for both TP and TN.

Nutrient concentrations in runoff can be affected by factors such as rainfall total and intensity, soil characteristics, turf condition, fertilizer application, and biological activity. Because of this, nutrient concentrations can be extremely variable. Table 2 summarizes typical lawn runoff concentrations for TP and TN based upon a study conducted by Herb Garn of the United States Geological Survey in 2003. Determining typical nutrient concentrations in runoff requires many samples collected from a wide range of rainfall events and site conditions in the area of interest. Measuring all of these factors is beyond the scope of this pilot project, but the largest factor, rainfall, can be somewhat accounted for by considering the storm characteristics associated with each runoff event. Simple rain gauges were used to track rainfall in 2006, so we can only report rain event totals (no rainfall intensity data) along with our sample results (Table 3 and Figure 5).

It is difficult to make any solid conclusions from the small data set collected in 2006, but it does appear that the measured concentrations for TP and TN generally fall within the typical ranges given in table 2, with the exception of site 1 which appears to be consistently low in TP in all three of the collected samples. Characterizing runoff from more lawns over a wider range of dates and rain event characteristics would help to clarify any trends and patterns in lawn runoff and would be a valuable addition to the overall Weaver Lake management plan.
